Manhole Inspection Summary

Manhole # S21G__001MH

Location Address: **26 ADDISON ST** Cross Street: **FAYETTE-FAIRMOUNT**

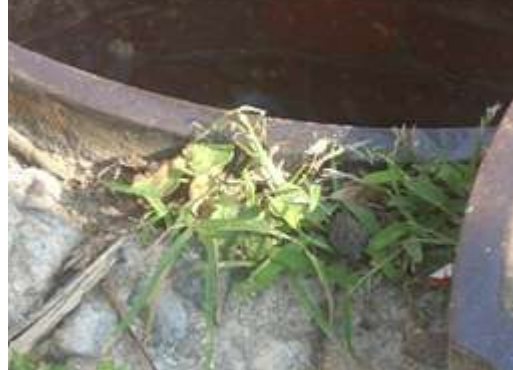
Defect 5

Cover Shape: **Circular** Diameter: **24** (in.) Length: (in.) Dist A/B Grade: **1** (in.)

GRADE ADJUSTMENT

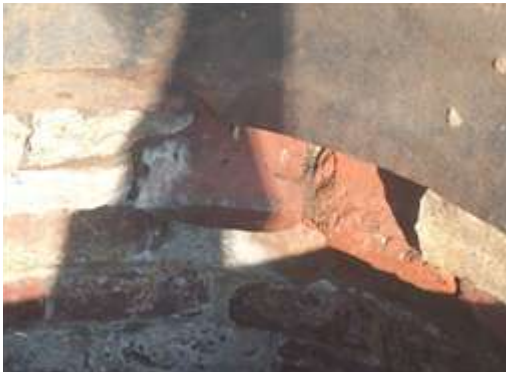
Defect 4

Condition: ☐ Sound ☐ Cracked ☐ Root Intrusion ☒ **Loose Brick** ☒ **Deteriorated**

LOOSE CHIMNEY BRICKS

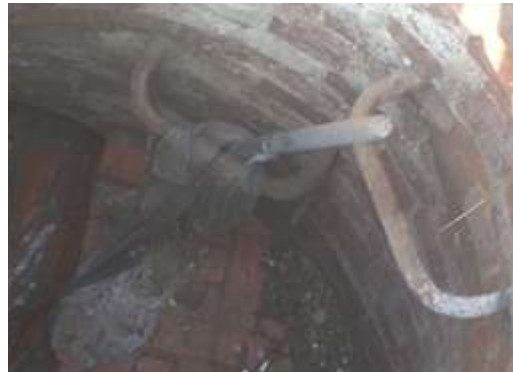
Defect 3

Steps Count: **2** Missing: **0** ☒ **Corroded**

Surcharge ☒ **Evidence Of Surcharge** Depth: **1** (ft.) ☐ Active Surcharge Present

CORRODED STEPS AND SURCHARGE
EVIDENCE ON STEPS

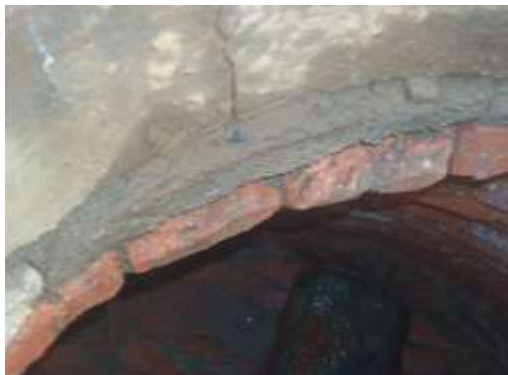
Defect 2

DETERIORATION OF CHIMNEY

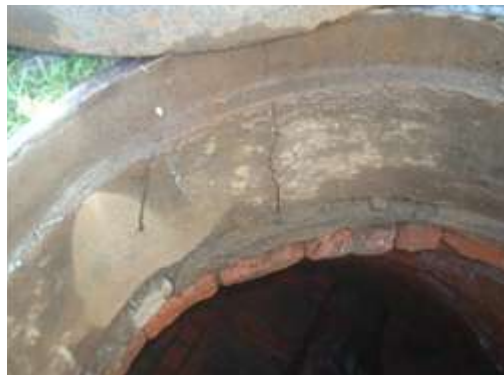
Defect 1

Frame Offset: **0** (in.) Condition: ☐ Sound ☒ **Cracked** ☐ Leaks

CRACKED FRAME
